Re: Inspection Summary Letter  
Turkey Creek Regional Sewer District  
PWSID IN5243032

**PUBLIC WATER SYSTEM SANITARY SURVEY REPORT**  
INDIANA DEPARTMENT OF ENVIRONMENTAL MANAGEMENT

| PWS Name:<br>Turkey Creek Regional Sewer District | PWSID Number:<br>IN5243032 | |

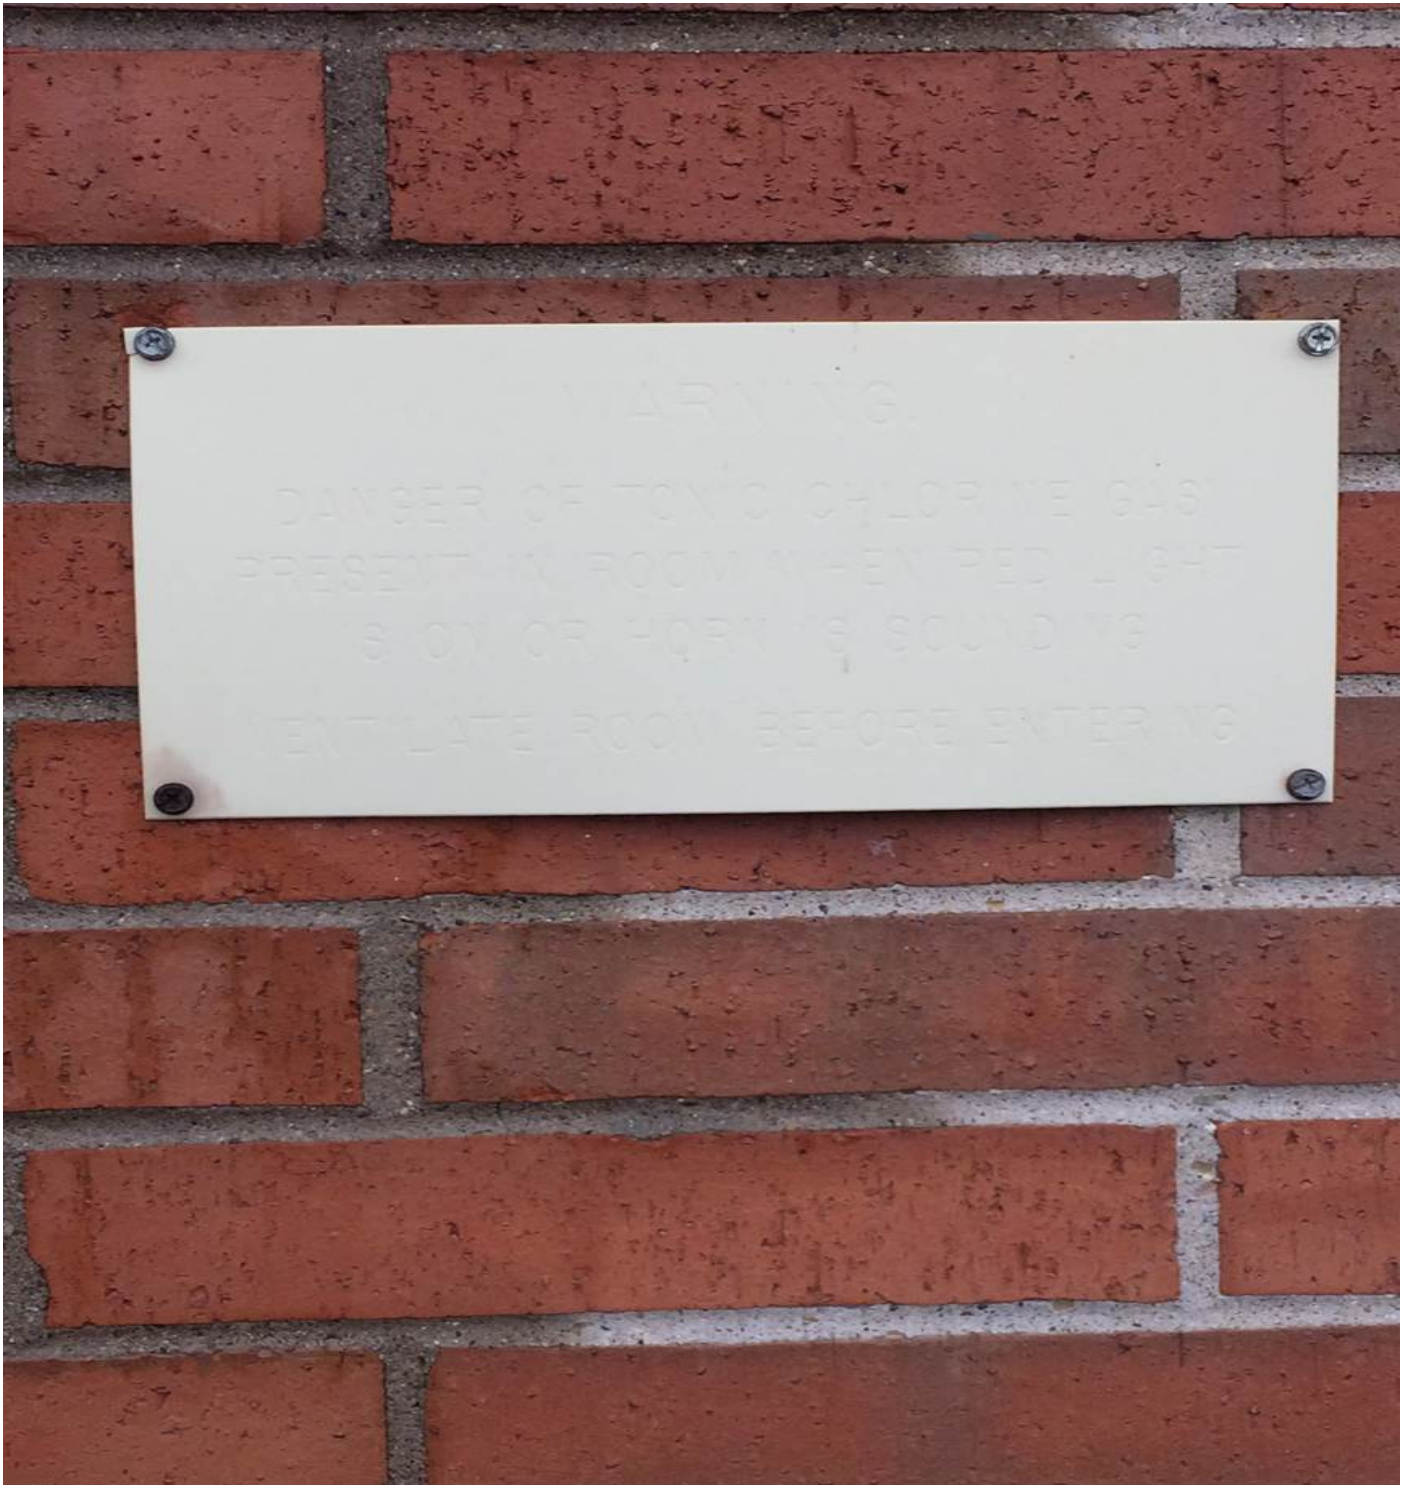
**10 States Standards 2.18 states in part: Consideration must be given to the safety of water plant personnel and visitors. The design must comply with all applicable safety codes and regulations that may include the Uniform Building Code, Uniform Fire Code, National Fire Protection Association Standards, and state and federal OSHA standards. Items to be considered include noise arresters, noise protection, confined space entry, protective equipment and clothing, gas masks, safety showers and eye washes, handrails and guards, warning signs, smoke detectors, toxic gas detectors and fire extinguishers.**

The signage on the chlorine room door, as well as on the wall next to it need to be refreshed or replaced as they are faded and in a state of disrepair.

**The signage on the chlorine room door, as well as on the wall next to it need to be refreshed or replaced as they are faded and in a state of disrepair.**

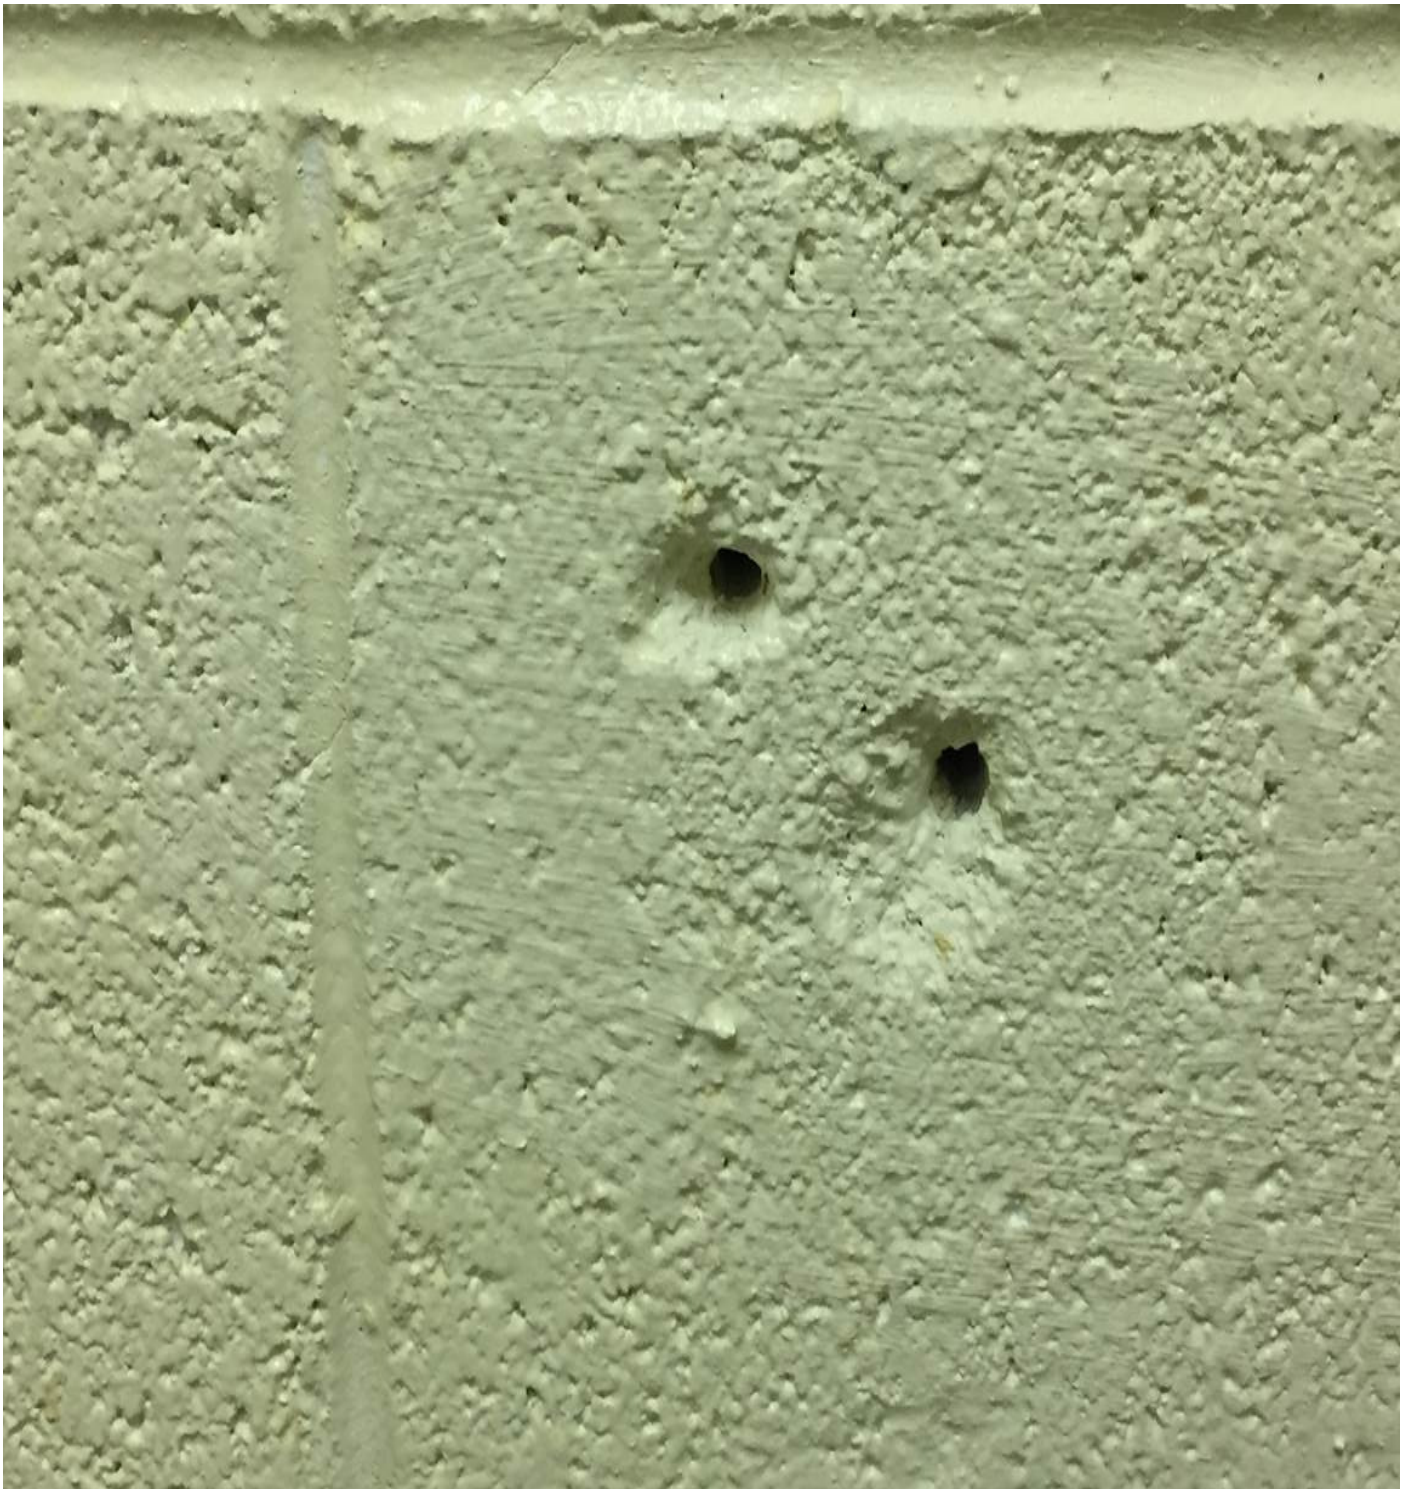
**10 States Standards 5.3 states in part: 1. Respiratory protection equipment, meeting the requirements of the National Institute for Occupational Safety and Health (NIOSH) shall be available where chlorine gas is handled 2. Shall be stored at a convenient heated location, but not inside any room where chlorine is used or stored. 3. The units shall use compressed air, have at least a 30 minute capacity, and be compatible with or exactly the same as units used by the fire department responsible for the plant. 10 States Standards 5.3.3 states in part: Where pressurized chlorine gas is present, continuous chlorine leak detection equipment is required and shall be equipped with both an audible alarm and a warning light. 10 States Standards 5.4 states in part: 1. Chlorine gas feed and storage shall be enclosed and separated from other operating areas. 2. The chlorine room shall be provided with a shatter resistant inspection window installed in an interior wall. 3. Constructed in such a manner that all openings between the chlorine room and the remainder of the plant are sealed. 4. Provided with doors equipped with panic hardware, assuring ready means of exit and opening outward only to the building exterior. 5. Each chlorine room shall have a ventilating fan with a capacity which provides one complete air change per minute when the room is occupied; where this is not appropriate due to the size of the room a lesser rate may be considered. 6. The ventilating fan shall take suction near the floor as far as practical from the door and air inlet, with the point of discharge so located as not to contaminate air inlets to any rooms or structures. 7. Air inlets shall be through corrosion resistant louvers near the ceiling. 8. Louvers for chlorine room air intake and exhaust shall facilitate airtight closure. 9. Separate switches for the ventilating fan and for the lights shall**

---There are small holes in the wall of the chlorine room. The system is to plug them. ---  
 The fan and light in the chlorine room are controlled by a single switch which is located on the outside of the building. It does not appear to be protected from vandalism. It will be researched and determined whether or not this is an acceptable set-up and the system will be provided with direction.---The system does not have SCBA on the premises. They are to either obtain it or utilize their Emergency Response Plan (ERP) to directly establish a process for dealing with a chlorine leak. ---

There are small holes in the wall of the chlorine room. The system is to plug them.

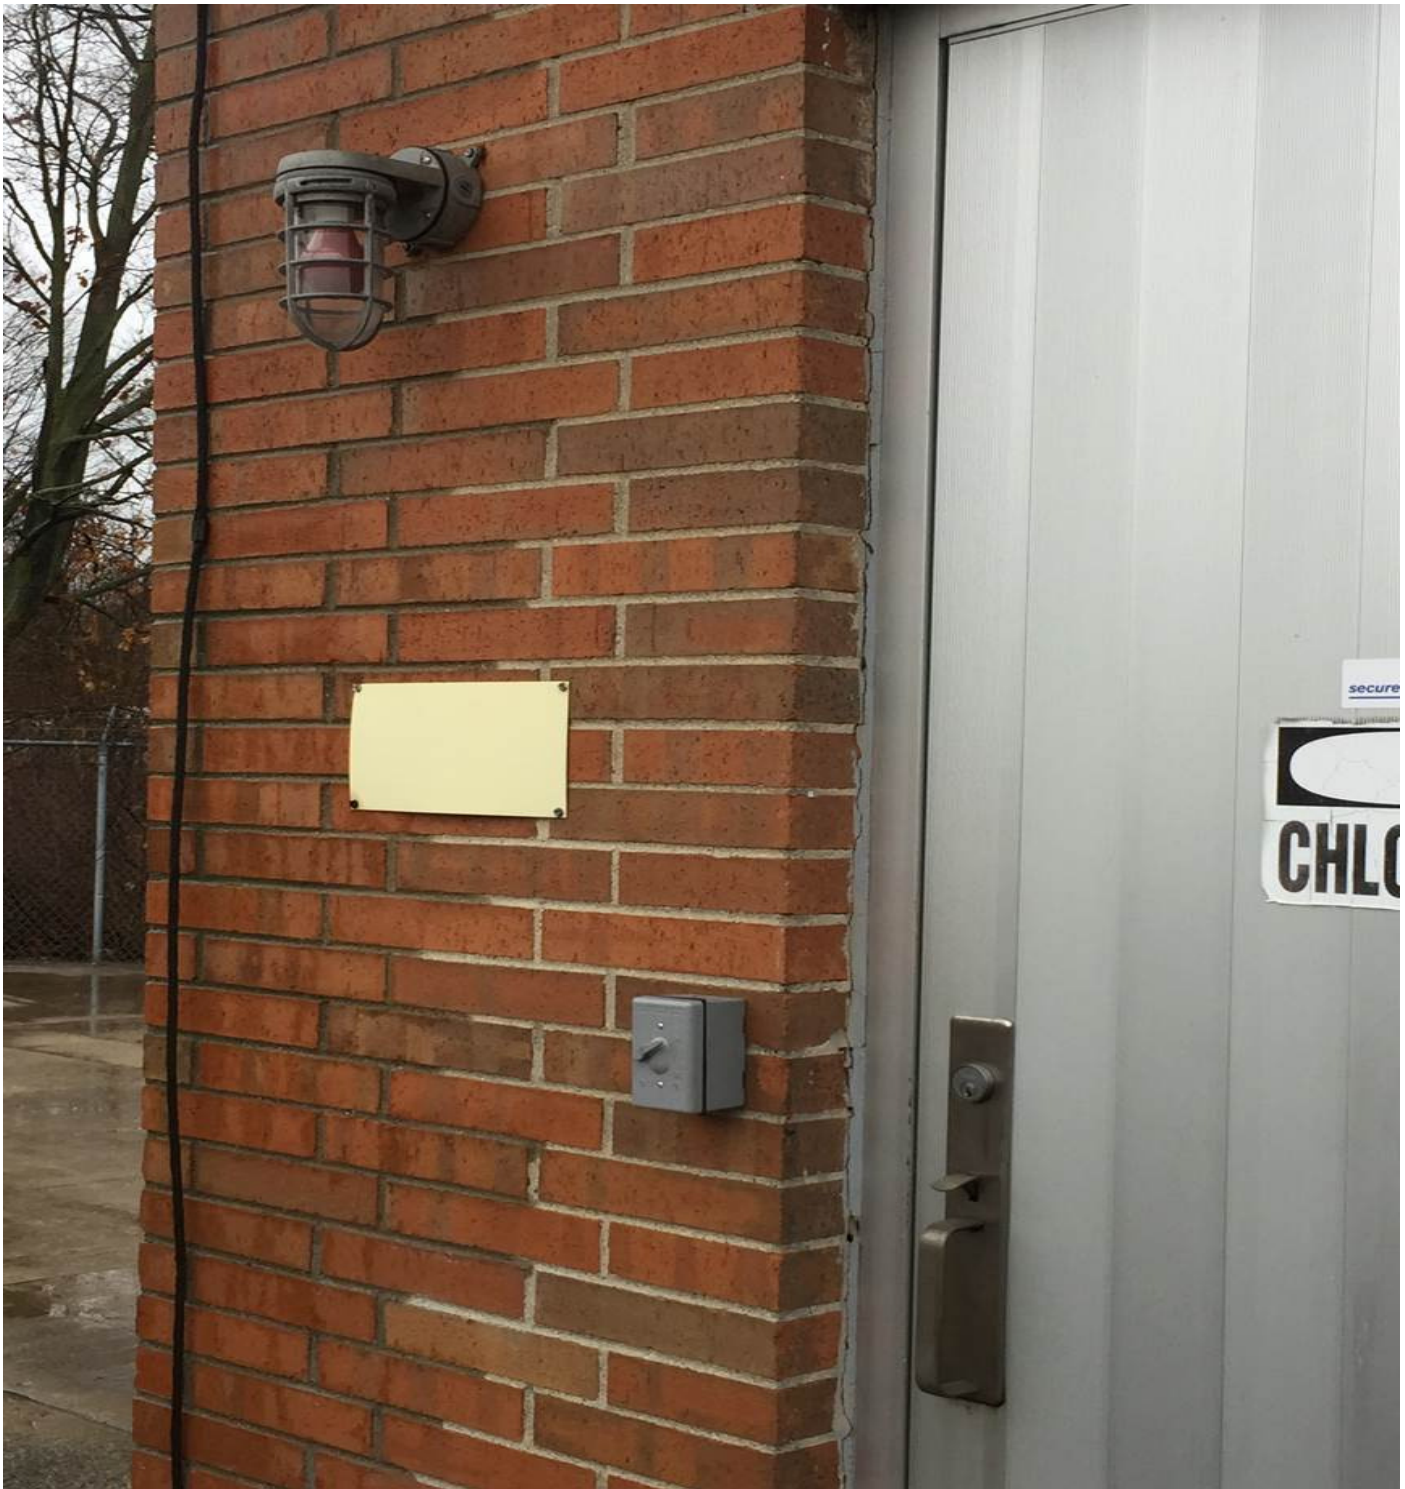
The fan and light in the chlorine room are controlled by a single switch which is located on the outside of the building. It does not appear to be protected from vandalism. It will be researched and determined whether or not this is an acceptable set-up and the system will be provided with direction.

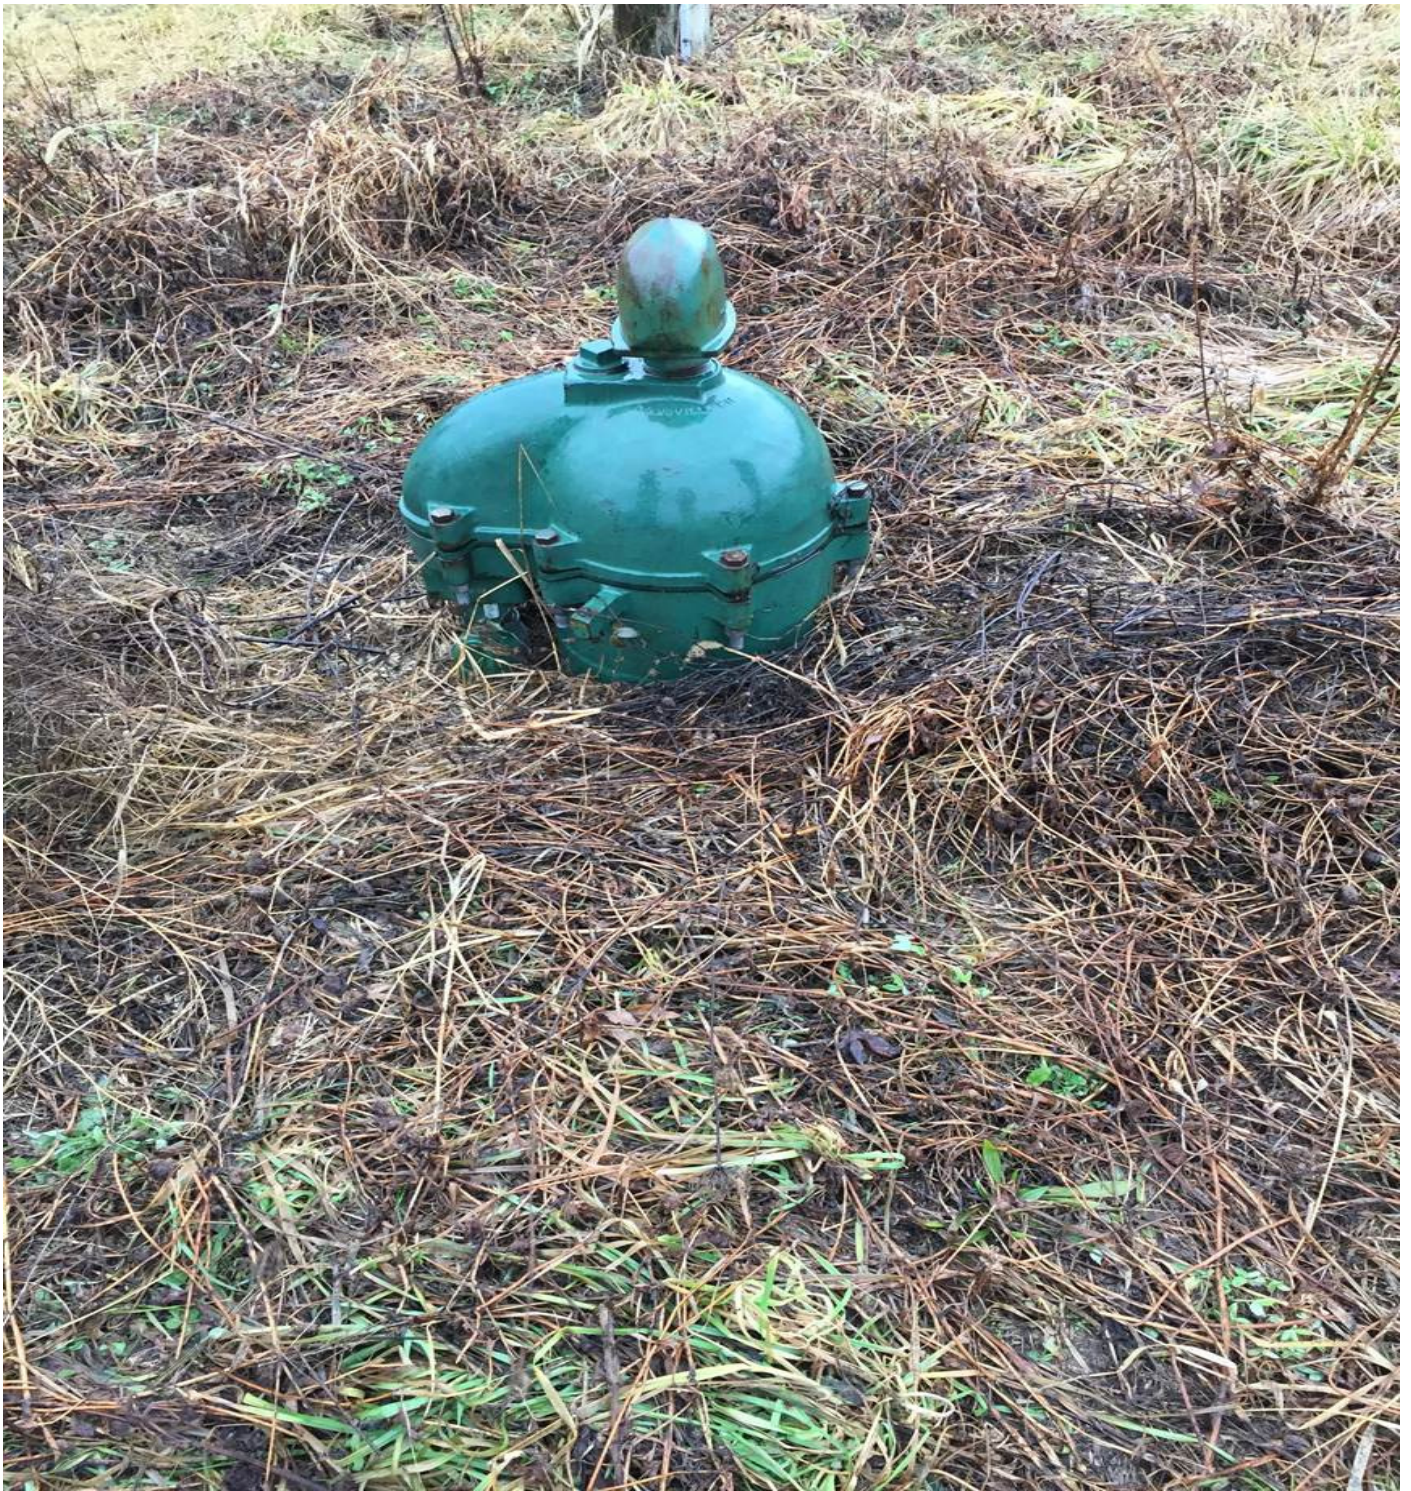
**Deficiency - 327 IAC 8-2-8.2(e)(1)(B) states in part: For a PWS using ground water, in whole or in part, the following shall be evaluated for deficiencies: Activities or pollution sources in the sanitary setback area or immediate source water area that will cause risks.**

**Deficiency - 327 IAC 8-2-8.2(e)(7)(E)(ii) states in part: Deficiencies relating to system management and operations, including the following: Failure by the PWS to operate and maintain the water system in a manner to ensure providing water that meets all requirements of the Act (Title 42, U.S.C.A. 300F through 300j-26) and IC 13-18-16-6. Measures to meet these requirements must include having and implementing a written or otherwise documented approach for the following: Maintaining a record of system components, including information necessary to: (AA) operate; (BB) maintain; and (CC) repair; system components.**

**Deficiency - 327 IAC 8-2-8.2(e)(1)(G)(i)(AA) states in part: For a PWS using ground water, in whole or in part, the following shall be evaluated for deficiencies: (i) Location or condition of a well making it vulnerable to surface water runoff or flooding, including: (AA) elevation of casing not protected from a one hundred (100) year flood.**

---There are low areas around the outdoor well that are susceptible to the pooling of water. The system is to fill these in.---

---Vegetation overgrowth is an issue near the outdoor well. The system is to find a way to control this without the use of chemicals.---

**Vegetation overgrowth is an issue near the outdoor well. The system is to find a way to control this without the use of chemicals.**

**Recommendation: It would be a good idea for the system to erect a barrier (e.g. ballasts, landscaping rock) to help protect the outdoor well from lawn equipment.**

**There are low areas around the outdoor well that are susceptible to the pooling of water. The system is to fill these in.**

---Recommendation: It would be a good idea for the system to erect a barrier (e.g. ballasts, landscaping rock) to help protect the outdoor well from lawn equipment.---
