March 19, 2018

Re: Inspection Summary Letter  
Turkey Creek Regional Sewer District  
PWSID IN5243032

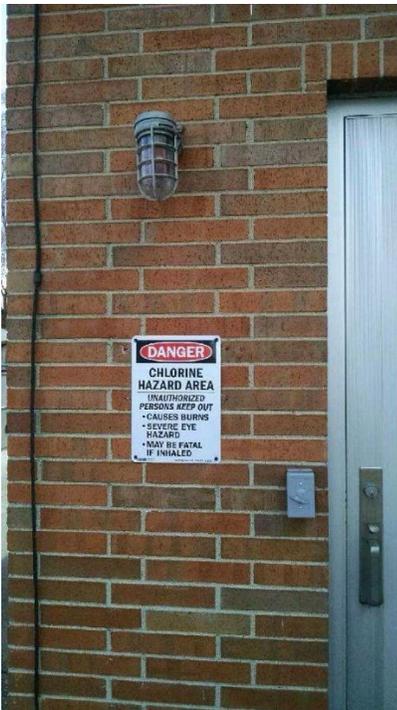
TCRSD has replaced the deficient sign. See attached photo #1&2.

New Chlorine Signage #1

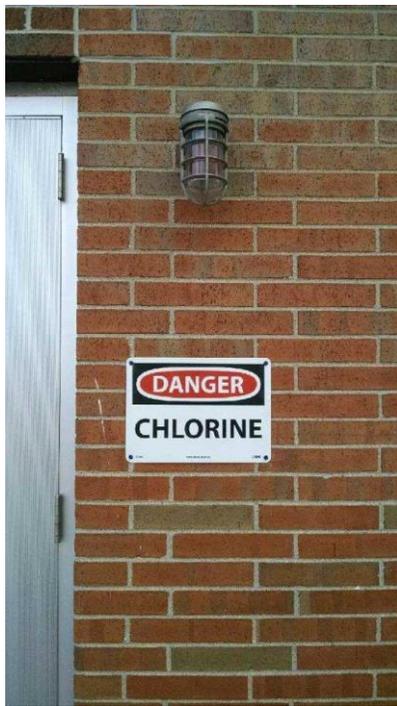
New Chlorine Signage #2

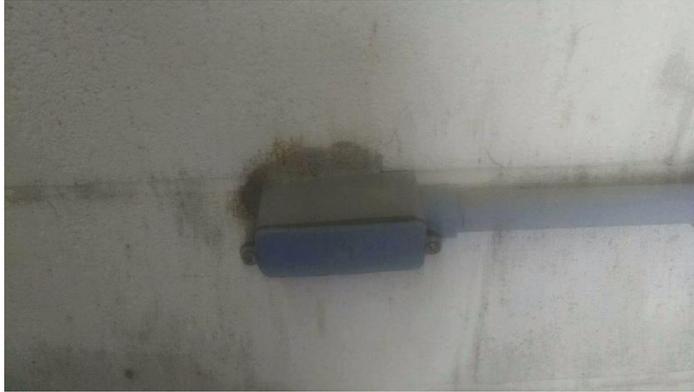
TCRSD has plugged the small holes identified during the inspection. See attached photo #3,4,5.

Chlorine room wall patch #1

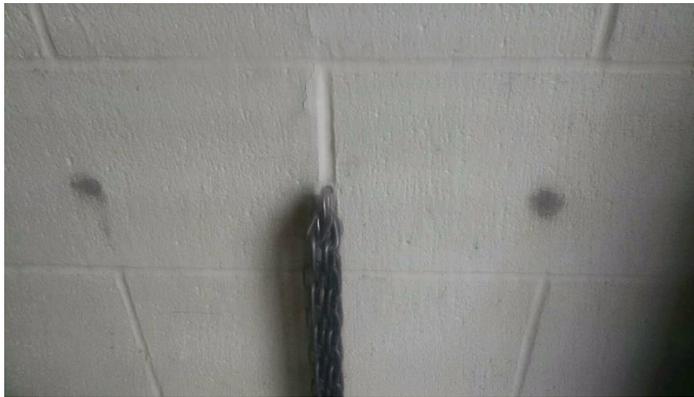
Chlorine room wall patch #2

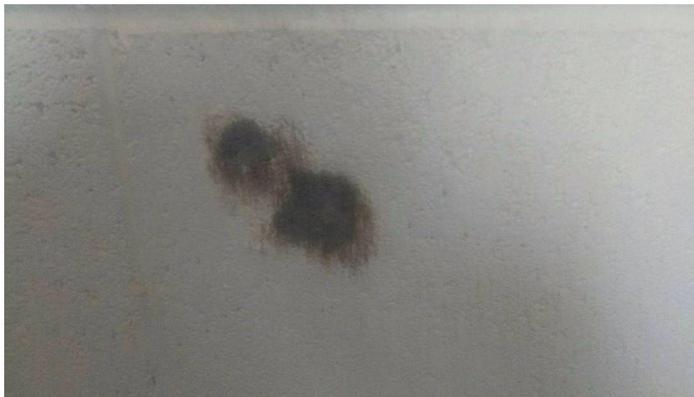
Chlorine room wall patch #3
