Turkey Creek Regional Sewer District

Water Utility Preliminary Engineering Report 2024

Submitted by Jones & Henry Engineers, Ltd.
2420 N. Coliseum Blvd, Suite 214, Fort Wayne, IN 46805

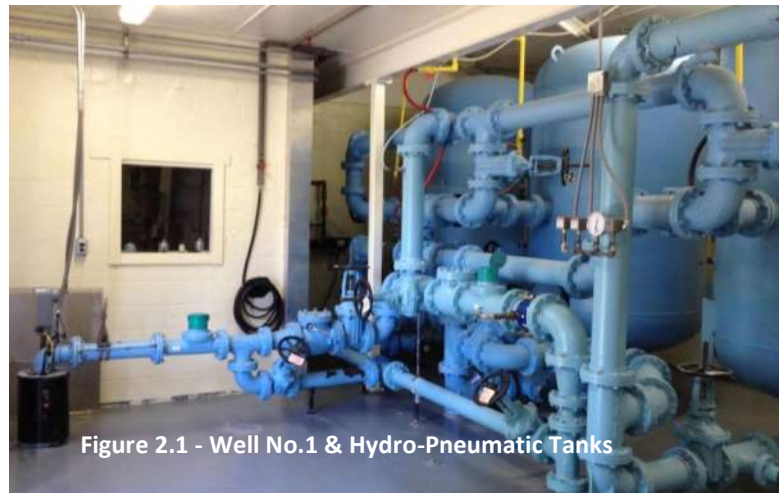
Figure 2.1 - Well No.1 & Hydro-Pneumatic Tanks

- Well 1 is approximately 72 feet in depth with 11 feet of 10-inch diameter screen. The well pump is currently rated at 200 GPM @ 161-ft. Well 1 was constructed in 1963. In 2023 the well's pump, column, and screen were replaced.
- Well 2 is approximately 78 feet in depth with 15 feet of 12-inch screen. This well currently pumps at 250 GPM @ 164 ft. Well 2 was constructed in 1998. In 2023 this well had a pump and column replaced. Well 2 is normally left as the backup pump since it is the larger of the two pumps and larger than the normal system demands.
- A new replacement well can be constructed on property currently owned by the district that is located north of the Water Treatment Plant

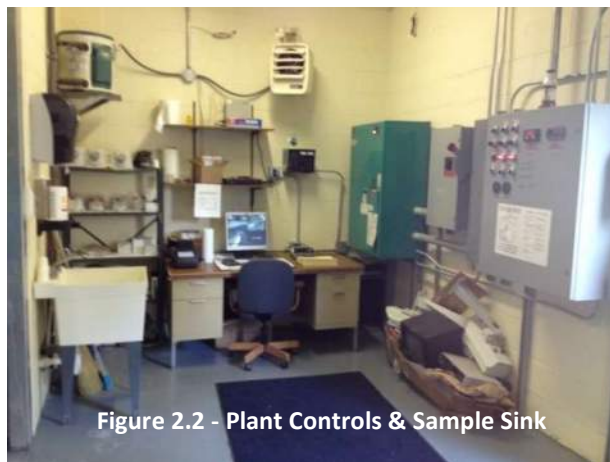
Figure 2.2 - Plant Controls & Sample Sink

The Water Treatment Plant has a design capacity of 200 GPM. The facility includes chemical addition of phosphate to sequester iron and manganese, fluoride (currently not added), and on-site hypochlorite solution generation for disinfection. The ground water

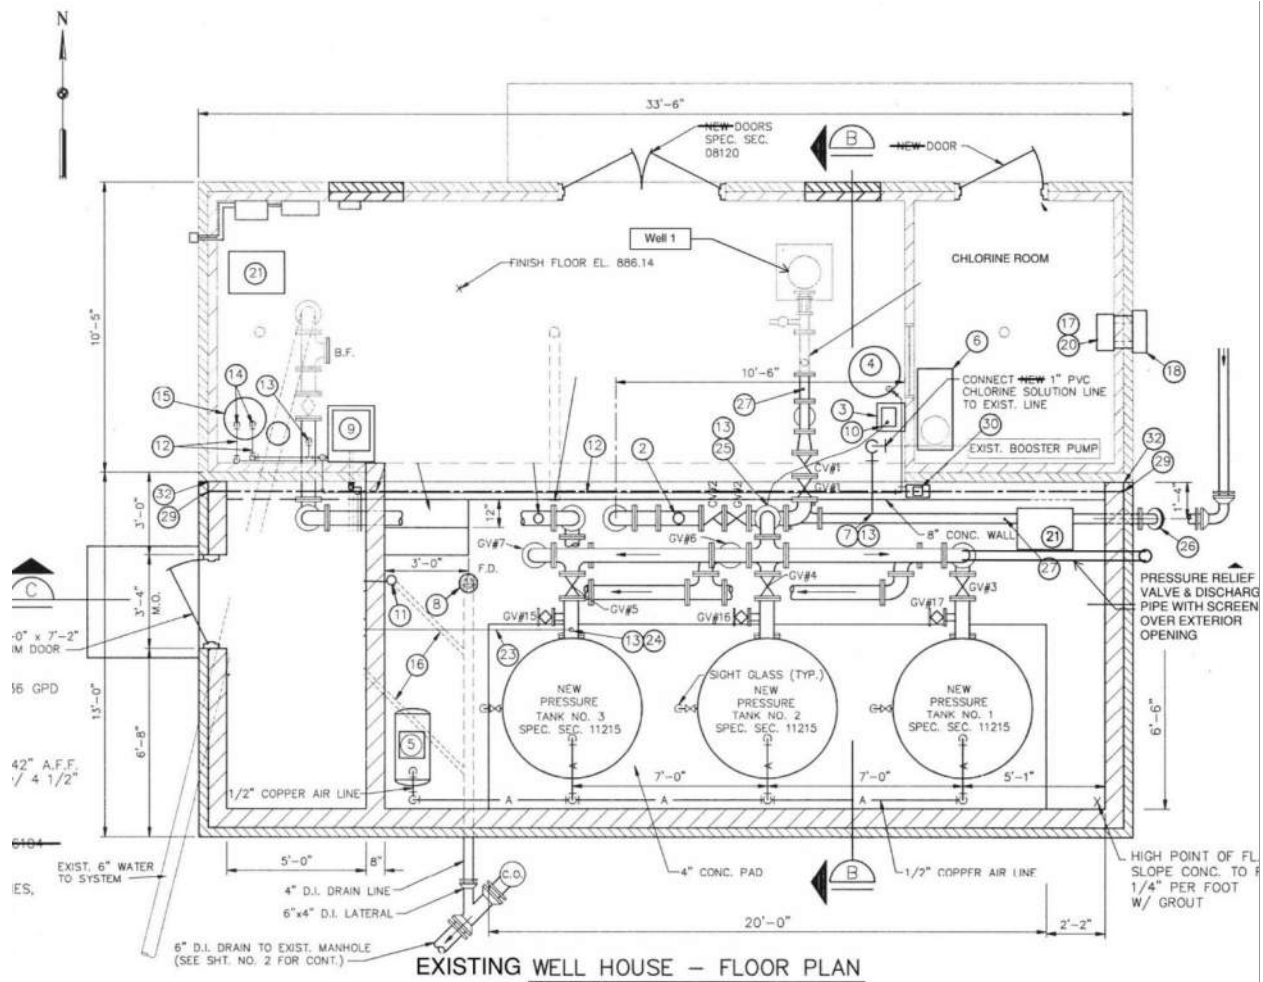
Figure 2.3 – Water Plant Plan View

supply wells pump through the Water Treatment Plant into three hydro-pneumatic tanks located in the treatment plant building and then into the system. Figure 2.3 presents a view of the piping and the hydro pneumatic tanks within the Water Treatment Plant.

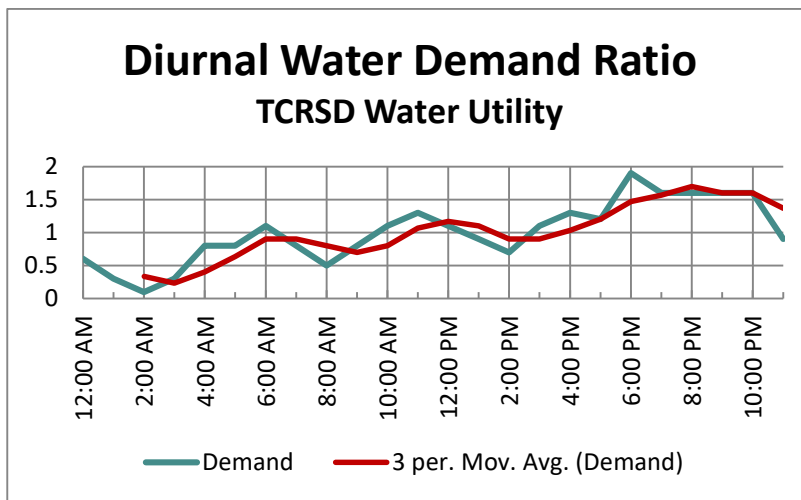
Figure 2.3 – Diurnal Water Demand Ratio

The following figure shows the diurnal demand curve that was developed from the pressure recordings.

The above information was used in calibrating the model at the time when the model was first developed. The peak hour demands during max day are estimated to be 180 GPM. The system was designed for 200 GPM. The smallest well will provide 200 GPM and the largest well will provide 250 GPM. Therefore, this system is adequately sized to distribute the water to meet demands within the distribution system.

Jones & Henry installed pressure recording meters at three separate locations within the distribution system and monitored pressures from April 2013 through October 2013. During this period of time, pressures were being recorded every minute. This information was used to calibrate the distribution model and also used to determine cycle times on the ground water supply pumps and to determine the diurnal demand within the system.

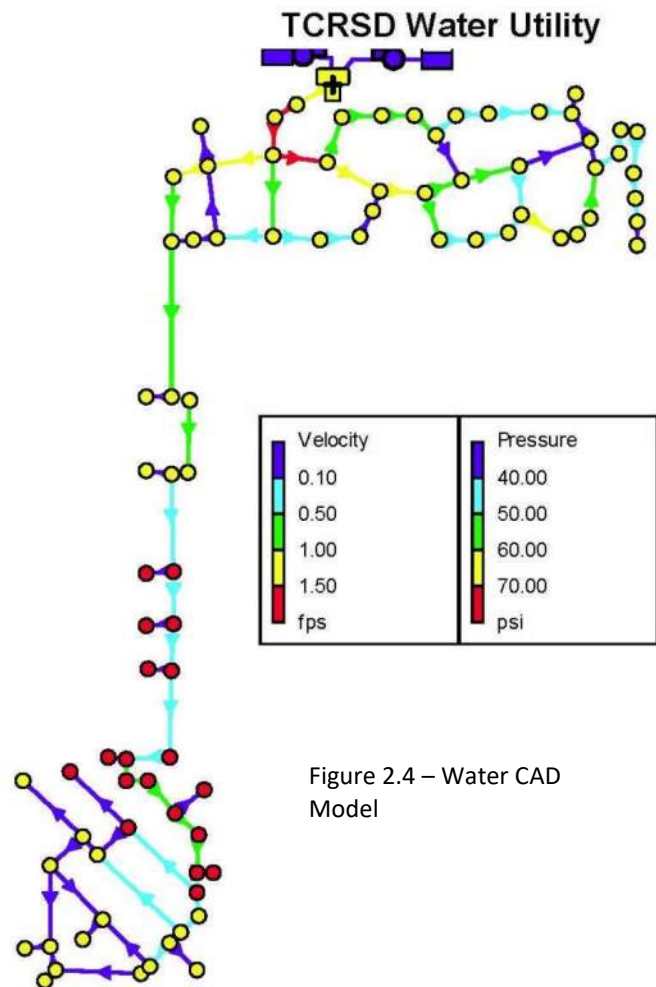
Figure 2.4 – Water CAD Model

As a tool for reviewing, studying, and recommending alternatives, we first developed a computer model of the distribution system in EPANET and imported it into WaterCAD. The computer model is used to simulate normal daily demands, maximum day demands and fire flows in the distribution system. Typically, per Ten State Standards, water distribution systems are normally developed using only 6-inch and larger water mains. However, due the period and design of the system at the time, a larger number of undersized 3- and 4-inch water mains were installed in the system before Turkey Creek took ownership of the system. The model was used to determine the hydraulic constraints within the existing distribution system, and to evaluate the improvements to reduce or eliminate the hydraulic constraints. The model was also used to review and determine water main sizing for future growth based on future demands, storage needs, and plant capacities.

Due to the water line sizes and the demands in the distribution system results in low velocities throughout the distribution system. This further lends itself towards settling of oxidized Iron and Manganese. The model indicates only several pipes within the distribution system that are at or approaching the recommended 2 feet per second (fps) during peak demands. During normal average day demands the velocities within the distribution are well below 0.5 fps. Increasing water age and further oxidation of the iron and manganese settling within the distribution system.

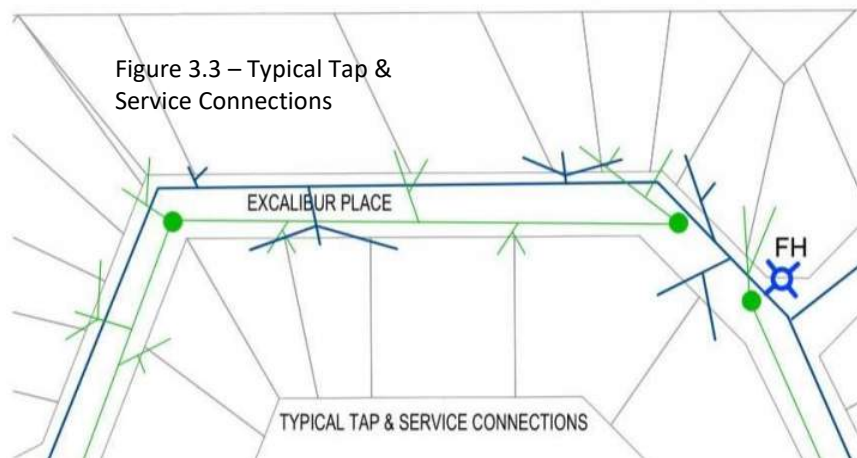
4. **Service Connections:** The District is aware that multiple homes are connected to the water mains through one service connection. Furthermore, the water services are not metered. Multiple residents have complained of low pressure. The model shows that low pressure is not the result of the distribution system but is most likely the result of multiple homes tapped off a single undersized service connection, see Figure below. This situation is predominated in the

Fascination Place portion of the service area and entails an estimated 168 users. The only alternative to replacing the service connection is to increase the pressure in the distribution system. The distribution

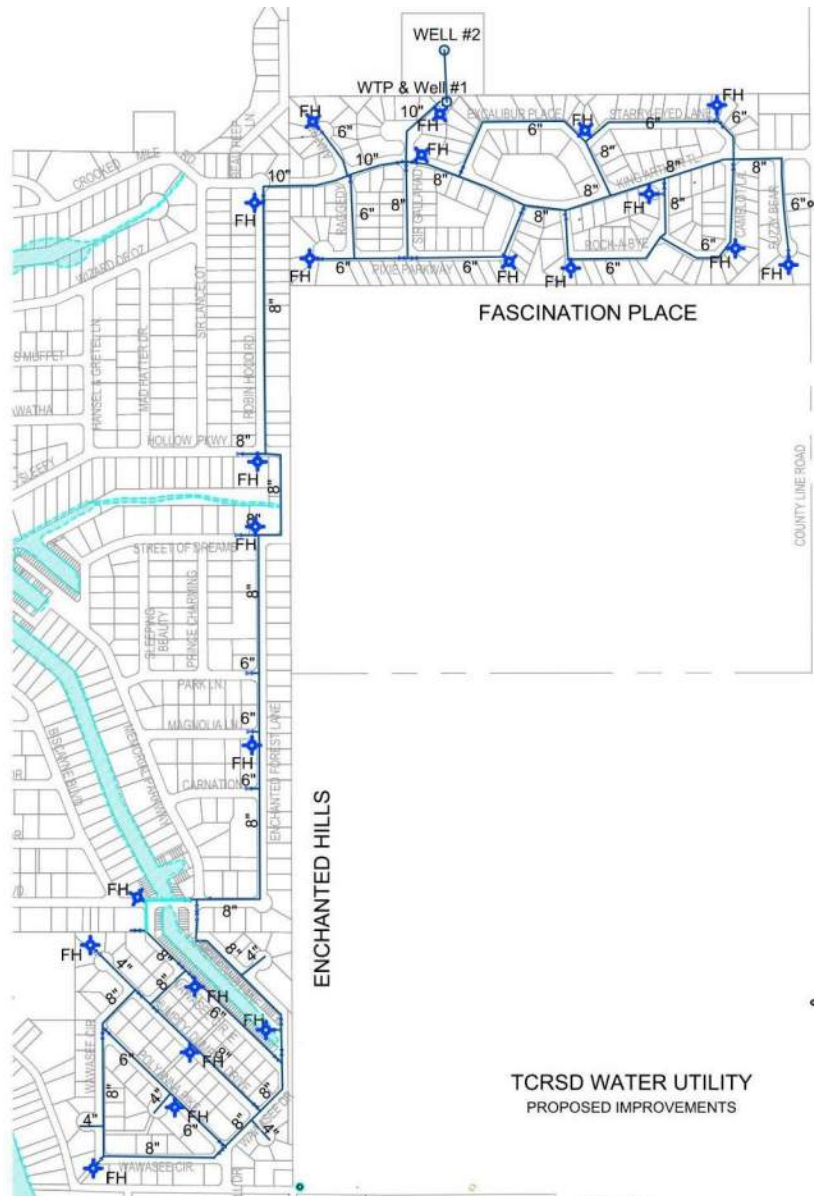
Figure 4.2 – Proposed Watermain Project

The Cost of this improvement for complete replacement of the distribution system is \$6,464,000.

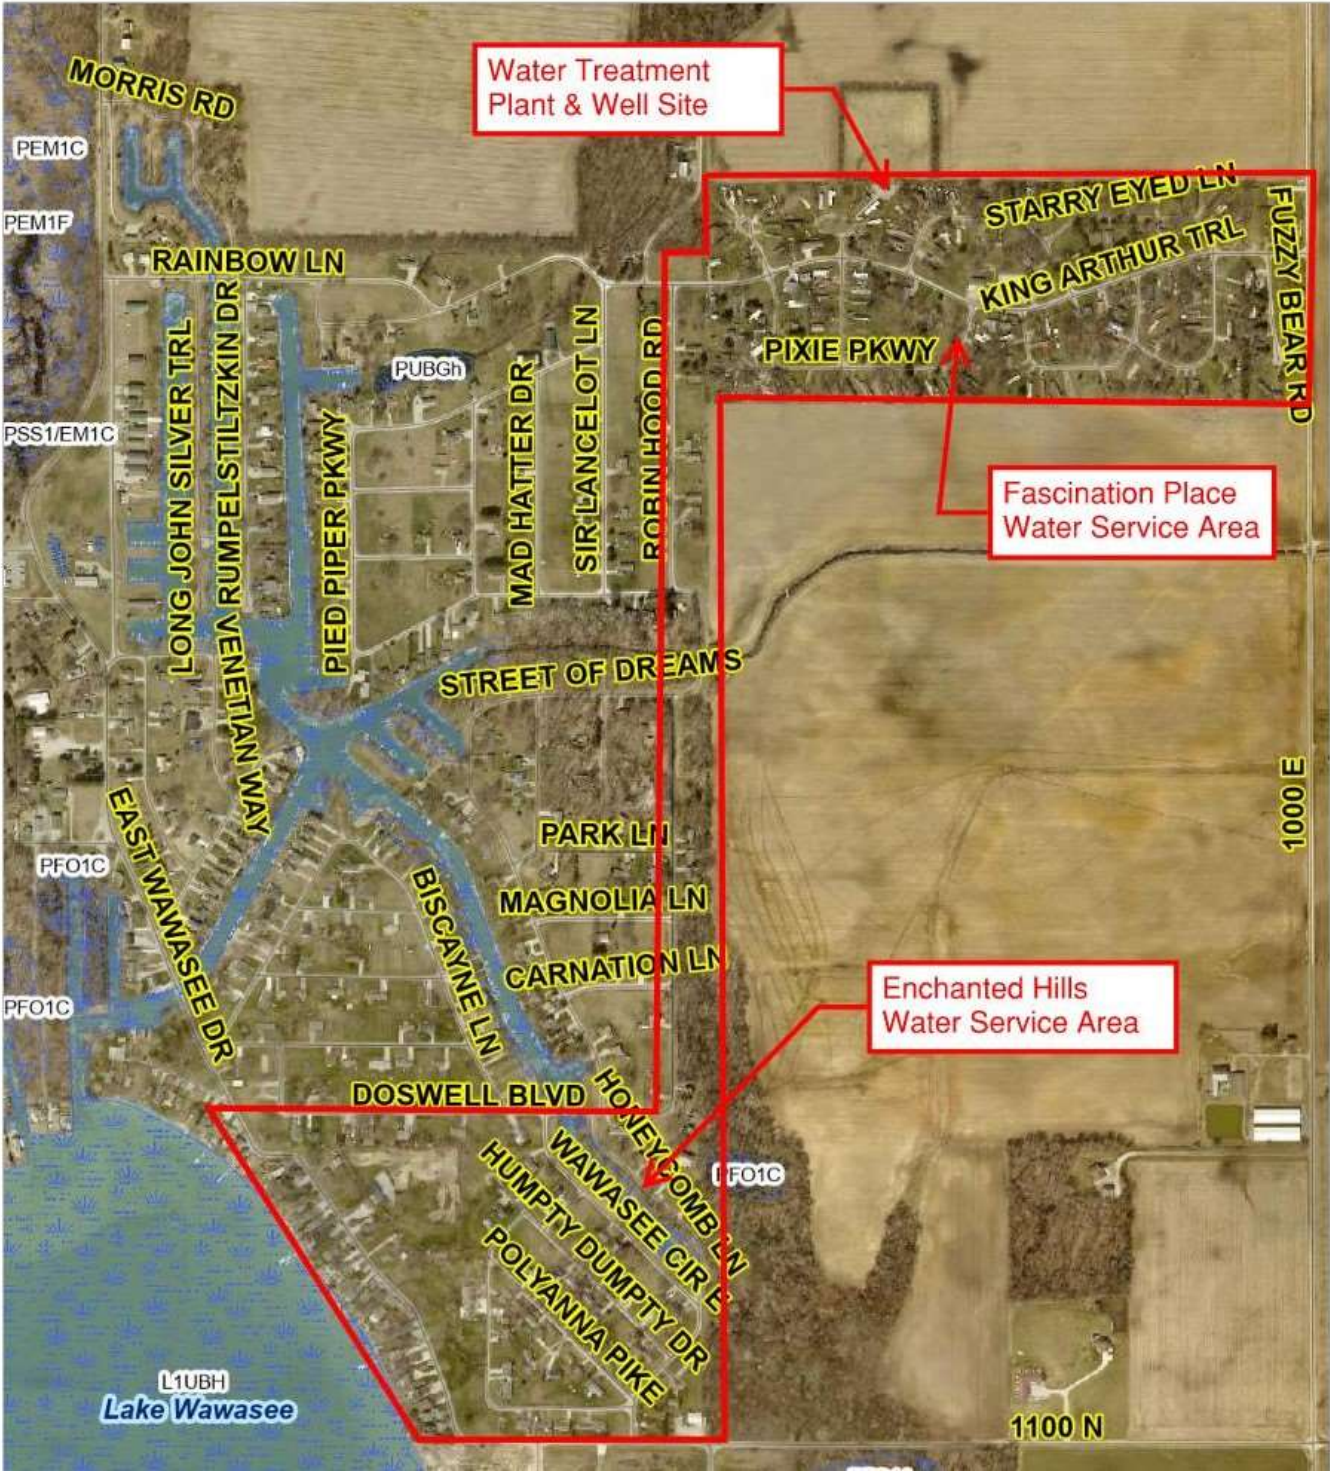
Figure 5.3
Wetland Map
Kosciusko County
GIS

EH water wetland map

No wetlands will be impacted by this project. Any necessary dewater or construction run-off would need to be controlled and filtered during construction and stormwater BMP solutions, see Appendix 5, Figure 5.3 Firm Map
